**Flood Control Project Maintenance
Levee Inspections**

Maintenance Issue Types Only, Levee Inspection Report By Mile - Spring 2019

Reclamation District No. 0817 Carlin

Waterway	Bank	Unit Miles	Inspection Start/End	Inspector
Unit No. 01 South Dry Creek	Left	3.81	04/03/2019 04/03/2019	Sterling York

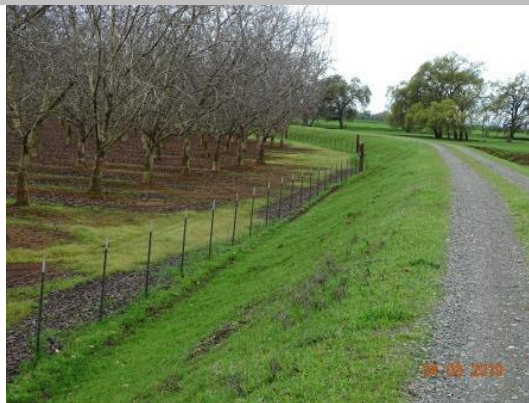
Photo 1 of 1 : SP_2019_RD0817_12_26_20190408_00017.jpg

LM Start	0.00	Rating **	A	Issue No.	26
LM End	3.81	Issue Type +	Ma	Location *	LS
Category	Earthen Levee			GPS Latitude/Longitude	
				Start	End
Item	Vegetation			38.984668 °	39.019765 °
				-121.506110 °	-121.454085 °
DWR ID	DWR_RD0817_01_s_2019_26				
Comment Code					
V1 : Control annual grass and weeds on the levee slopes and easements.					
Inspector Comment					
The annual vegetation is well maintained, Spring 2019.

View looking downstream landside of the well maintained annual vegetation, Spring 2019.

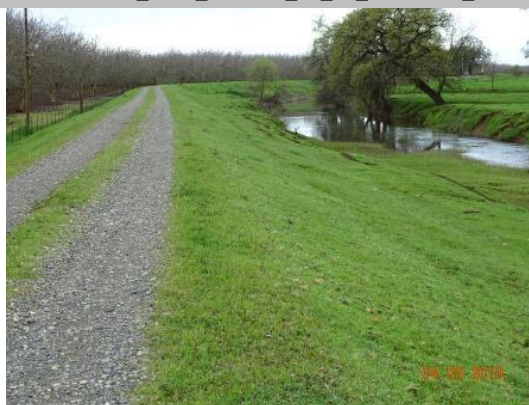
Photo 1 of 1 : SP_2019_RD0817_12_27_20190408_00018.jpg

LM Start	0.00	Rating **	A	Issue No.	27	
LM End	3.81	Issue Type +	Ma	Location *	WS	
Category	Earthen Levee			GPS Latitude/Longitude		
				Start	End	
Item	Vegetation			38.984668 °	39.019765 °	
				-121.506110 °	-121.454085 °	
DWR ID	DWR_RD0817_01_s_2019_27					
Comment Code						
V1 : Control annual grass and weeds on the levee slopes and easements.						
Inspector Comment						
The annual vegetation is well maintained, Spring 2019.

View looking downstream waterside of the well maintained annual vegetation, Spring 2019.

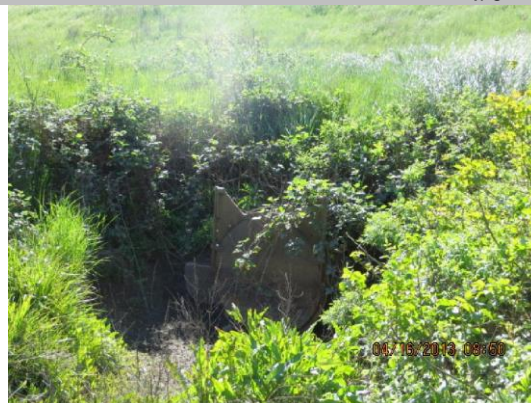
Photo 1 of 3 : UCIP_SP_2019_42685_19865.jpg

LM Start	0.29	Rating **	M	Issue No.	28
LM End	0.29	Issue Type +	Ma	Location *	
Category	Supplemental			GPS Latitude/Longitude	
				Start	End
Item	DWR UCIP LMA Responsibility			38.987813 °	38.987813 °
				-121.502963 °	-121.502963 °
DWR ID	18985				
Comment Code					
Inspector Comment					
FS_ID:42685 DS_ID:18985 EP_NO: N/A Repair Type: Non-Urgent Crossing Status: Found UCIP Comments: 04/16/2013 Dense vegetation on waterward and landward slopes limit visual inspection of potential leaks along pipe alignment. Recommend having owner clear vegetation along slopes. (P. Amatya - DWR UCIP) FIELD_STRUCT_DESC: 48-inch corrugated metal gravity drainage pipe through the levee, 23.3 feet below the crown. Flap gate on the waterside (WS) end. [Additional Reference(s): DWR Levee Log, 2005. USACE Sacramento O&M Manual 146, November 1962, (HLM 0.28)]. FS Date: 4/16/2013

WS- pipe, flap gate in dense vegetation on berm

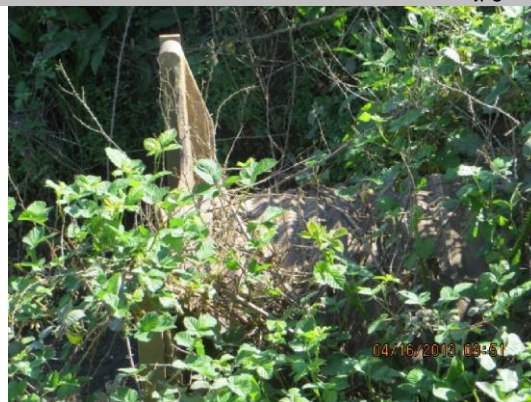
Photo 2 of 3 : UCIP_SP_2019_42685_19864.jpg

WS- CM pipe and flap gate

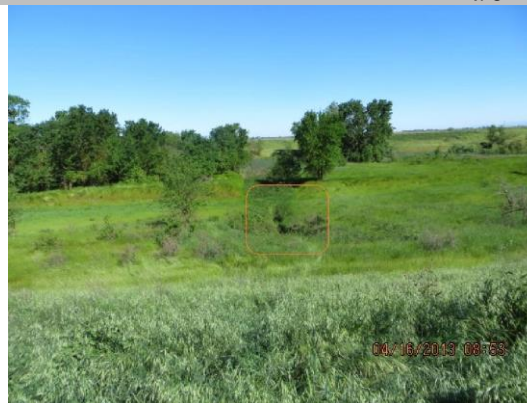
Photo 3 of 3 : UCIP_SP_2019_42685_19863.jpg

LM Start	0.29	Rating **	M	Issue No.	28 (cont)	
LM End	0.29	Issue Type +	Ma	Location *		
Category	Supplemental			GPS Latitude/Longitude		
				Start		End
Item	DWR UCIP LMA Responsibility			38.987813 °		38.987813 °
				-121.502963 °		-121.502963 °
DWR ID	18985					
Comment Code						
Inspector Comment						
FS_ID:42685 DS_ID:18985 EP_NO: N/A Repair Type: Non-Urgent Crossing Status: Found UCIP Comments: 04/16/2013 Dense vegetation on waterward and landward slopes limit visual inspection of potential leaks along pipe alignment. Recommend having owner clear vegetation along slopes. (P. Amatya - DWR UCIP) FIELD_STRUCT_DESC: 48-inch corrugated metal gravity drainage pipe through the levee, 23.3 feet below the crown. Flap gate on the waterside (WS) end. [Additional Reference(s): DWR Levee Log, 2005. USACE Sacramento O&M Manual 146, November 1962, (HLM 0.28)]. FS Date: 4/16/2013

WS- dense vegetation on WS of the levee

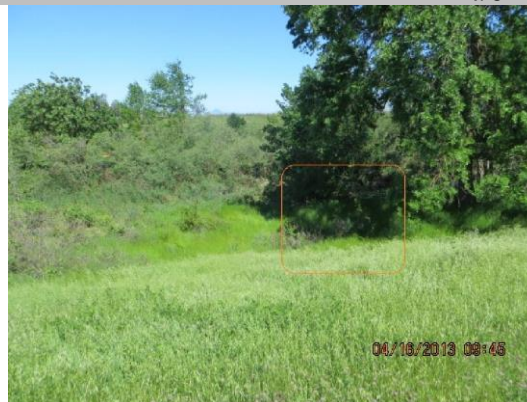
Photo 1 of 3 : UCIP_SP_2019_41153_19882.jpg

Comment Code					
Inspector Comment					
FS_ID:41153 DS_ID:18987 EP_NO: N/A Repair Type: Non-Urgent Crossing Status: Found UCIP Comments: 04/16/2013 Damaged slide gate on WS of the levee. Need to contact owner to determine status of crossing. If crossing is no longer in use owner will need to contact CVFPB to comply with Title 23. Dense vegetation on waterward and landward slopes limit visual inspection of potential leaks along pipe alignment. Recommend having owner clear vegetation along slopes. (P. Amatya - DWR UCIP) FIELD_STRUCT_DESC: *ABANDONED* 18-inch corrugated metal gravity drainage pipe through the levee, 14.9 feet below the crown. Slide gate on the waterside (WS) end. [Additional Reference(s): DWR Levee Log, 2005. USACE Sacramento O&M Manual 146, November 1962, (HLM 1.34)]. FS Date: 4/16/2013

WS- overview of WS area

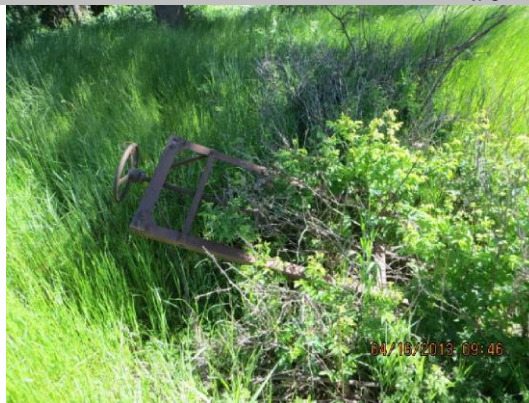
Photo 2 of 3 : UCIP_SP_2019_41153_19881.jpg

Comment Code						
Inspector Comment						
FS_ID:41153 DS_ID:18987 EP_NO: N/A Repair Type: Non-Urgent Crossing Status: Found UCIP Comments: 04/16/2013 Damaged slide gate on WS of the levee. Need to contact owner to determine status of crossing. If crossing is no longer in use owner will need to contact CVFPB to comply with Title 23. Dense vegetation on waterward and landward slopes limit visual inspection of potential leaks along pipe alignment. Recommend having owner clear vegetation along slopes. (P. Amatya - DWR UCIP) FIELD_STRUCT_DESC: *ABANDONED* 18-inch corrugated metal gravity drainage pipe through the levee, 14.9 feet below the crown. Slide gate on the waterside (WS) end. [Additional Reference(s): DWR Levee Log, 2005. USACE Sacramento O&M Manual 146, November 1962, (HLM 1.34)]. FS Date: 4/16/2013

WS- closer look at damaged slide gate on WS

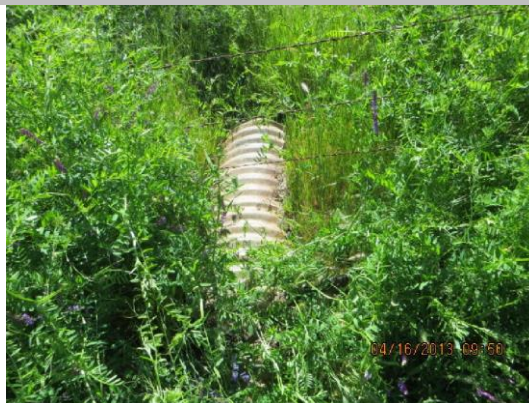
Photo 3 of 3 : UCIP_SP_2019_41153_19884.jpg

LS- CMP on toe of the levee.

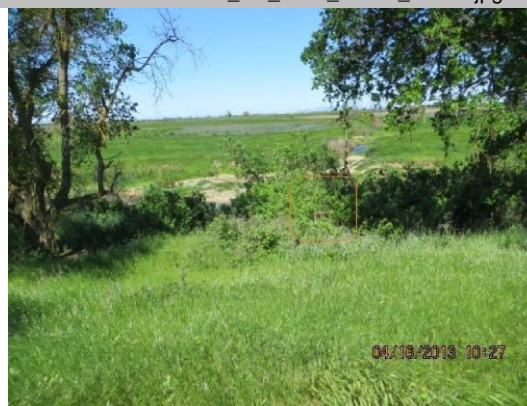
Photo 1 of 3 : UCIP_SP_2019_41157_19892.jpg

Comment Code					
Inspector Comment					
FS_ID:41157 DS_ID:18988 EP_NO: N/A Repair Type: Non-Urgent Crossing Status: Found UCIP Comments: 04/16/2013 A buried slide gate on WS of the levee. Need to contact owner to determine status of crossing. If crossing is no longer in use owner will need to contact CVFPB to comply with Title 23. Dense vegetation on waterward and landward slopes limit visual inspection of potential leaks along pipe alignment. Recommend having owner clear vegetation along slopes. (P. Amatya - DWR UCIP) FIELD_STRUCT_DESC: *ABANDONED* 18-inch corrugated metal gravity drainage pipe through the levee, 13.8 feet below the crown. Slide gate on the waterside (WS) end. [Additional Reference(s): DWR Levee Log, 2005. USACE Sacramento O&M Manual 146, November 1962, (HLM 1.62)]. FS Date: 4/16/2013

WS- overview of WS berm

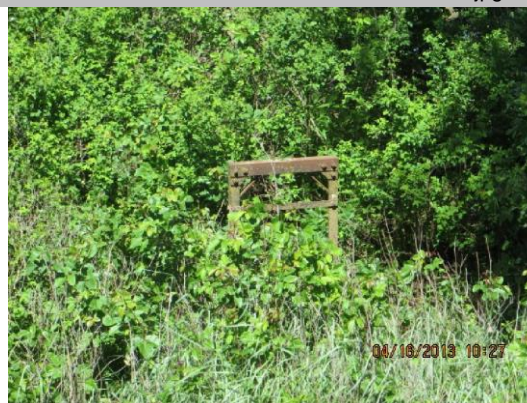
Photo 2 of 3 : UCIP_SP_2019_41157_19891.jpg

WS- slide gate

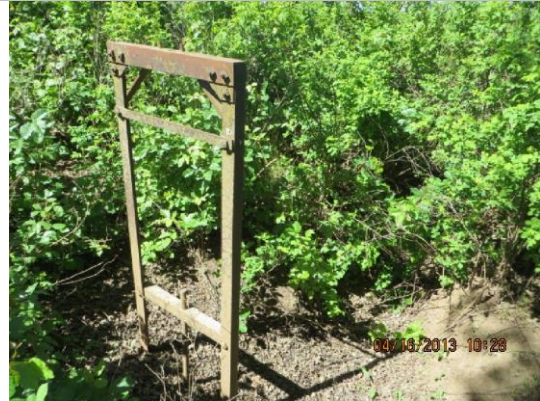
Photo 3 of 3 : UCIP_SP_2019_41157_19890.jpg

Comment Code						
Inspector Comment						
FS_ID:41157						
DS_ID:18988						
EP_NO: N/A						
Repair Type: Non-Urgent						
Crossing Status: Found						
UCIP Comments: 04/16/2013 A buried slide gate on WS of the levee. Need to contact owner to determine status of crossing. If crossing is no longer in use owner will need to contact CVFPB to comply with Title 23. Dense vegetation on waterward and landward slopes limit visual inspection of potential leaks along pipe alignment. Recommend having owner clear vegetation along slopes. (P. Amatya - DWR UCIP)						
FIELD_STRUCT_DESC: *ABANDONED* 18-inch corrugated metal gravity drainage pipe through the levee, 13.8 feet below the crown. Slide gate on the waterside (WS) end. [Additional Reference(s): DWR Levee Log, 2005. USACE Sacramento O&M Manual 146, November 1962, (HLM 1.62)].						
FS Date: 4/16/2013

WS- buried slide gate

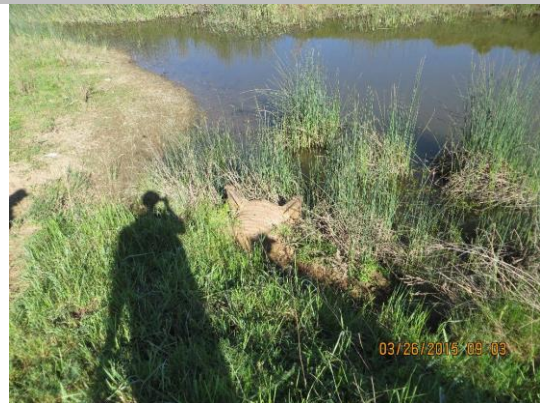
Photo 1 of 3 : UCIP_SP_2019_43946_73422.jpg

Comment Code					
Inspector Comment					
FS_ID:43946					
DS_ID:18992					
EP_NO: N/A					
Repair Type: Non-Urgent					
Crossing Status: Found					
UCIP Comments: 03/26/2015 Flapgate in closed position, but blocked from operation on WS toe. Pipe appears abandoned and should be verified as having been done so properly. (W. Wylie - DWR UCIP)					
FIELD_STRUCT_DESC: 36-inch corrugated metal gravity drainage pipe through the levee, 13.7 feet below the crown. Slide gate on the waterside (WS) end. Flap gate on the WS end. [Additional Reference(s): DWR Levee Log, 2005. USACE Sacramento O&M Manual 146, November 1962, (HLM 2.97)].					
FS Date: 3/26/2015

Pipe and flapgate visible on WS toe.

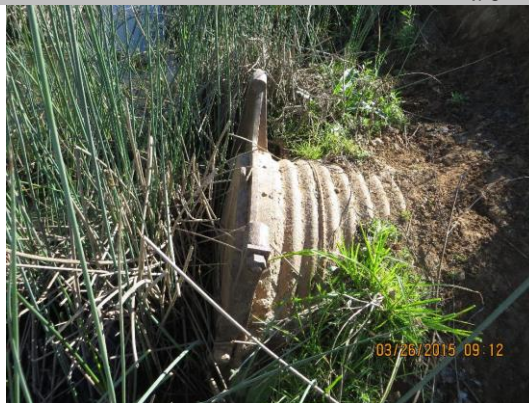
Photo 2 of 3 : UCIP_SP_2019_43946_73421.jpg

LM Start	2.96	Rating **	M	Issue No.	47 (cont)	
LM End	2.96	Issue Type +	Ma	Location *		
Category	Supplemental			GPS Latitude/Longitude		
				Start		End
Item	DWR UCIP LMA Responsibility			39.012552 °		39.012552 °
				-121.466538 °		-121.466538 °
DWR ID	18992					
Comment Code						
Inspector Comment						
FS_ID:43946 DS_ID:18992 EP_NO: N/A Repair Type: Non-Urgent Crossing Status: Found UCIP Comments: 03/26/2015 Flapgate in closed position, but blocked from operation on WS toe. Pipe appears abandoned and should be verified as having been done so properly. (W. Wylie - DWR UCIP) FIELD_STRUCT_DESC: 36-inch corrugated metal gravity drainage pipe through the levee, 13.7 feet below the crown. Slide gate on the waterside (WS) end. Flap gate on the WS end. [Additional Reference(s): DWR Levee Log, 2005. USACE Sacramento O&M Manual 146, November 1962, (HLM 2.97)]. FS Date: 3/26/2015

Pipe and flapgate visible on WS toe.

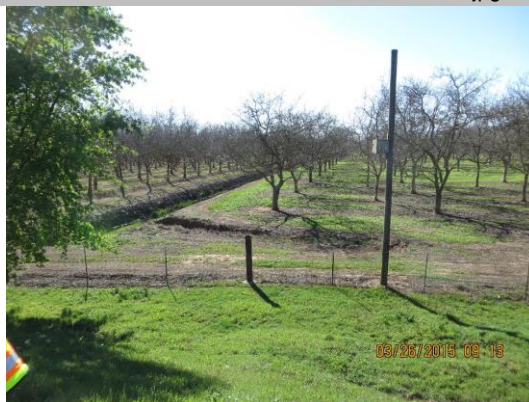
Photo 3 of 3 : UCIP_SP_2019_43946_73420.jpg

LS of pipe buried but alignment would place LS outlet just left of telephone pole on LS toe.

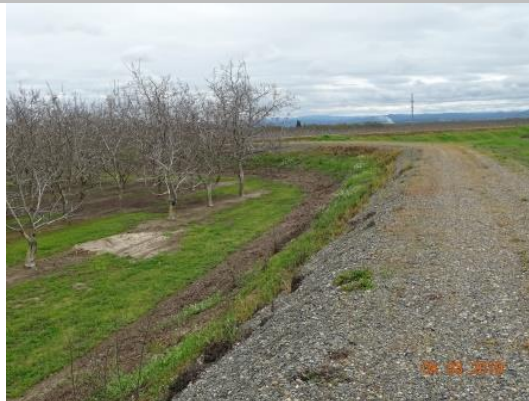
Photo 1 of 1 : SP_2019_RD0817_13_9_20190409_00026.jpg

View looking upstream landside of the well maintained vegetation, Spring 2019.

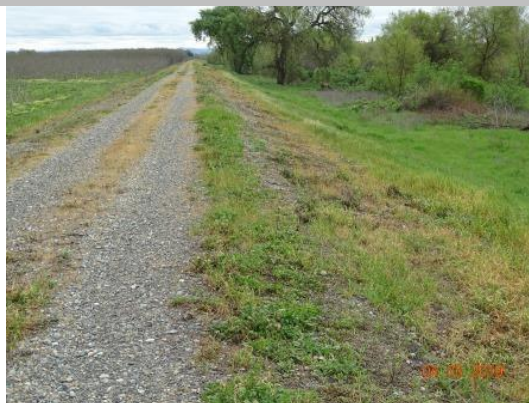
Photo 1 of 1 : SP_2019_RD0817_13_10_20190409_00027.jpg

LM Start	0.02	Rating **	A	Issue No.	10
LM End	3.82	Issue Type +	Ma	Location *	WS
Category	Earthen Levee			GPS Latitude/Longitude	
				Start	End
Item	Vegetation			38.984442 °	38.993108 °
				-121.505884 °	-121.437928 °
DWR ID	DWR_RD0817_02_s_2019_10				
Comment Code					
V1 : Control annual grass and weeds on the levee slopes and easements.					
Inspector Comment					
The annual vegetation is well maintained, Spring 2019.

View looking upstream waterside of the well maintained vegetation, Spring 2019.

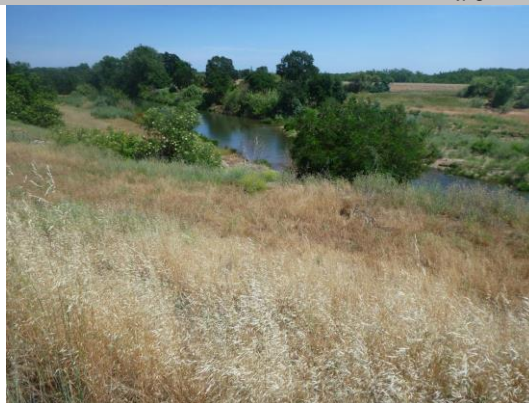
Photo 3 of 3 : LEVAL_SP_2019_162_289.jpg

LM Start	2.08	Rating **	A/W	Issue No.	13 (cont)	
LM End	3.18	Issue Type +	Ma	Location *		
Category	Supplemental			GPS Latitude/Longitude		
				Start	End	
Item	2017 Storm Damage			38.989338	°	38.994124
				-121.468640	°	-121.449448
DWR ID	DWR_RD0817_02_f_2017_13					
Comment Code						
Inspector Comment						
Levee Evaluation Comments						
Description:						
Site ID No:162						
Site Designation:DWR_RD0817_02_s_2012_10						
Repair Type: Stability						
Rating:Area of Concern						
Field Date:6/5/2017						
Notes: Stability issues are due to levee geometry. Narrow steep slopes.

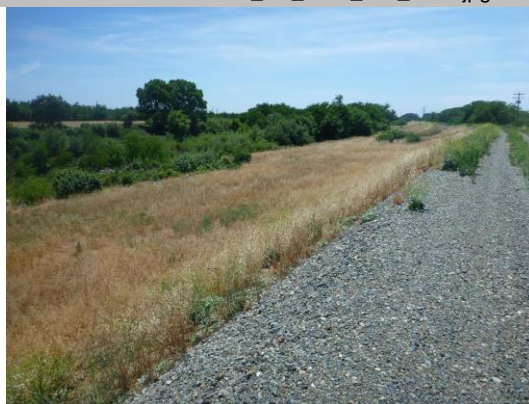
Photo 1 of 3 : LEVAL_SP_2019_161_1065.jpg

LM Start	2.72	Rating **	A/W	Issue No.	14
LM End	2.74	Issue Type +	Ma	Location *	
Category	Supplemental			GPS Latitude/Longitude	
				Start	End
Item	2017 Storm Damage			38.992170 °	38.992217 °
				-121.457332 °	-121.456967 °
DWR ID	DWR_RD0817_02_f_2017_14				
Comment Code					
Inspector Comment					
Levee Evaluation Comments					
Description:					
Site ID No:161					
Site Designation:240-3					
Repair Type: Erosion					
Rating:Area of Concern					
Field Date:6/5/2017					
Notes: No issue found. Narrow levee with steep slopes. Did not investigate bench due to rattlesnake concerns. Possible alternate location at 38.993282; -121.451562.

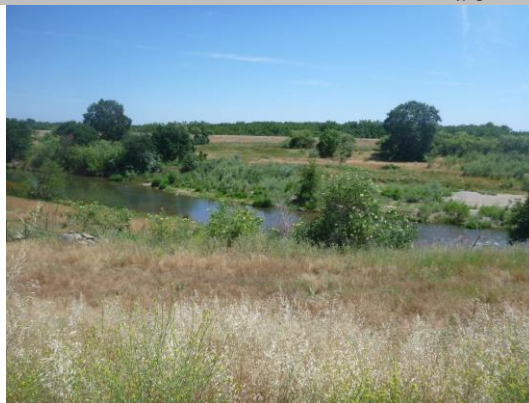
Photo 2 of 3 : LEVAL_SP_2019_161_283.jpg

LM Start	2.72	Rating **	A/W	Issue No.	14 (cont)
LM End	2.74	Issue Type +	Ma	Location *	
Category	Supplemental			GPS Latitude/Longitude	
				Start	End
Item	2017 Storm Damage			38.992170 °	38.992217 °
				-121.457332 °	-121.456967 °
DWR ID	DWR_RD0817_02_f_2017_14				
Comment Code					
Inspector Comment					
Levee Evaluation Comments					
Description:					
Site ID No:161					
Site Designation:240-3					
Repair Type: Erosion					
Rating:Area of Concern					
Field Date:6/5/2017					
Notes: No issue found. Narrow levee with steep slopes. Did not investigate bench due to rattlesnake concerns. Possible alternate location at 38.993282; -121.451562.

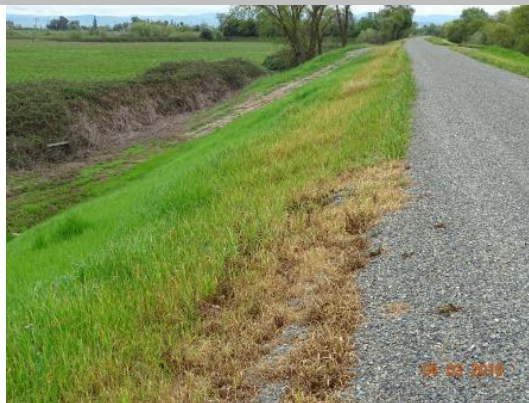
Photo 1 of 1 : SP_2019_RD0817_14_8_20190408_00023.jpg

View looking upstream landside at the well maintained annual vegetation, Spring 2019.

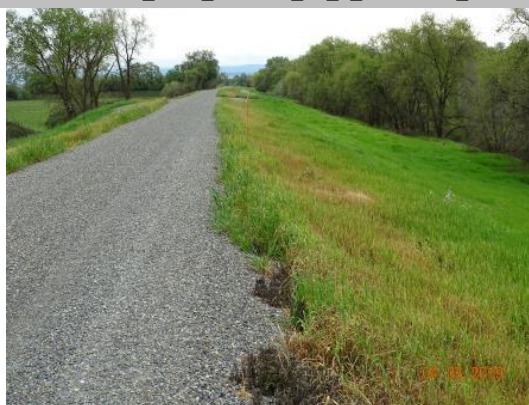
Photo 1 of 1 : SP_2019_RD0817_14_9_20190408_00024.jpg

LM Start	0.25	Rating **	A	Issue No.	9
LM End	1.57	Issue Type +	Ma	Location *	WS
Category	Earthen Levee			GPS Latitude/Longitude	
				Start	End
Item	Vegetation			38.987575 °	39.000612 °
				-121.506615 °	-121.490638 °
DWR ID	DWR_RD0817_03_s_2019_9				
Comment Code					
V1 : Control annual grass and weeds on the levee slopes and easements.					
Inspector Comment					
The annual vegetation is well maintained, Spring 2019.

View looking upstream waterside at the well maintained annual vegetation, Spring 2019.

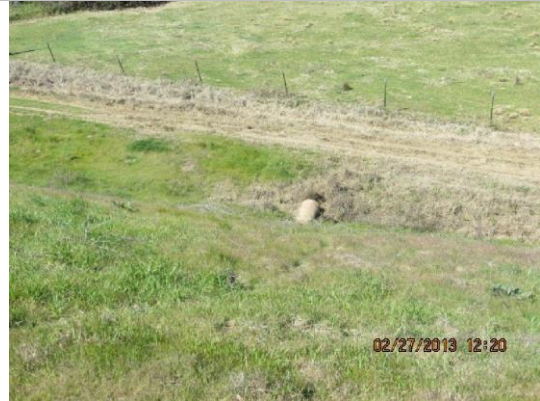
Photo 1 of 3 : UCIP_SP_2019_50231_54271.jpg

Comment Code						
Inspector Comment						
FS_ID:50231 DS_ID:22949 EP_NO: N/A Repair Type: Non-Urgent Crossing Status: Found UCIP Comments: 06/30/2016 Vegetation has been cleared at outlet enough to allow the flapgate to open by half a foot. Recommend rechecking WS outlet prior to flood season to ensure no overgrowth. Dense vegetation at LS but pipe still functional. Crossing has been downgraded from Urgent to Non-Urgent. (K. Fazel - UCIP)02/27/2013 Flap gate partially blocked by vegetation at outlet. (G. Wylie - FPIIB) FIELD_STRUCT_DESC: 18-inch corrugated metal gravity drainage pipe through the levee, 19.5 feet below the crown. Flap gate and headwall on the waterside (WS) end, headwall not found in 2016. (Due to a recent change in the levee alignment, this pipe is no longer in RD0784, Unit 6. Nevertheless, this pipe's original references remain in the RD0784 Levee Log and O&M Manual). [Additional Reference(s): DWR Levee Log, 2005. USACE Sacramento O&M Manual 145.1, August 1955, (Station 21+35), As-Built Drawing No. 2-4-106, Sheet 2, (Station 21+35)]. FS Date: 6/30/2016 9:02:00 AM

Pipe at LS toe

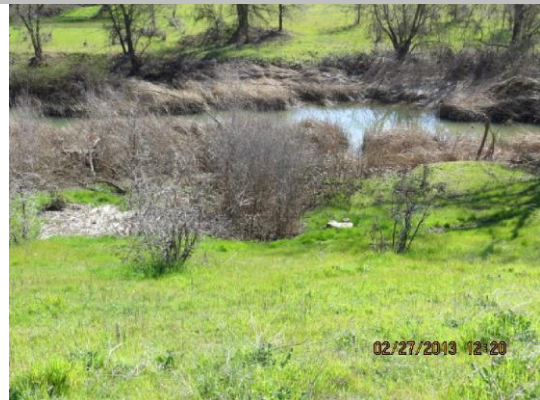
Photo 2 of 3 : UCIP_SP_2019_50231_54270.jpg

Outlet in brush at WS toe.

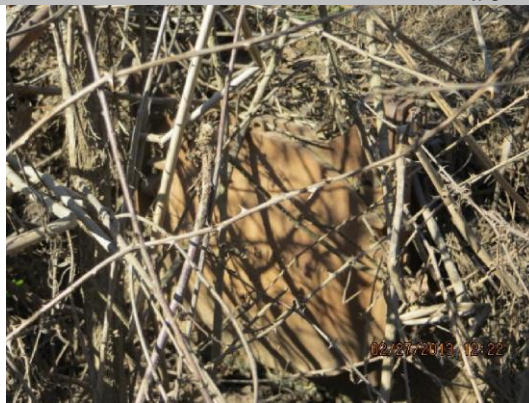
Photo 3 of 3 : UCIP_SP_2019_50231_54269.jpg

Comment Code						
Inspector Comment						
FS_ID:50231 DS_ID:22949 EP_NO: N/A Repair Type: Non-Urgent Crossing Status: Found UCIP Comments: 06/30/2016 Vegetation has been cleared at outlet enough to allow the flapgate to open by half a foot. Recommend rechecking WS outlet prior to flood season to ensure no overgrowth. Dense vegetation at LS but pipe still functional. Crossing has been downgraded from Urgent to Non-Urgent. (K. Fazel - UCIP)02/27/2013 Flap gate partially blocked by vegetation at outlet. (G. Wylie - FPIIB) FIELD_STRUCT_DESC: 18-inch corrugated metal gravity drainage pipe through the levee, 19.5 feet below the crown. Flap gate and headwall on the waterside (WS) end, headwall not found in 2016. (Due to a recent change in the levee alignment, this pipe is no longer in RD0784, Unit 6. Nevertheless, this pipe's original references remain in the RD0784 Levee Log and O&M Manual). [Additional Reference(s): DWR Levee Log, 2005. USACE Sacramento O&M Manual 145.1, August 1955, (Station 21+35), As-Built Drawing No. 2-4-106, Sheet 2, (Station 21+35)]. FS Date: 6/30/2016 9:02:00 AM

Flap gate blocked by vegetation on WS toe.

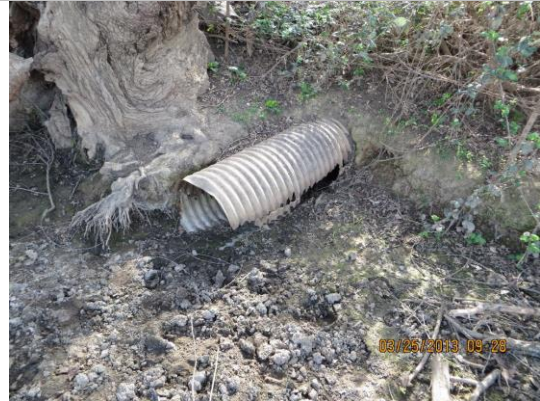
Photo 1 of 3 : UCIP_SP_2019_53420_53849.jpg

Comment Code						
Inspector Comment						
FS_ID:53420 DS_ID:22950 EP_NO: N/A Repair Type: Urgent Crossing Status: Found UCIP Comments: 10/30/2018 Same as last inspection. Pipe has several sections of wall missing throughout the pipe length, and there is significant pipe deformation on the LS. Spoke with Tom Engler (MBK Engeers), District Engineer, and he mentioned that a video inspection has been completed at this site and that a report is in progress. LMA will be seeking funding for pipe repair under DWR's Deferred Maintenance Project (DMP). Crossing remains Urgent due to the deteriorated condition of the pipe. (O. Magana - DWR UCIP)06/30/2016 Holes still present through pipe on corroded landside (LS) end. Pipe still half full of debris as visible thru LS end. Good candidate for removal via DWR's Deferred Maintenance Program. WS vegetation cleared in the immediate vicinity of flapgate. Potential for overgrowth at WS end nevertheless imminent. Note that this pipe does not cause LS nuisance flooding per Tom Engler of MBK. (K. Fazel - UCIP)03/25/2013 Pipe heavily corroded and failing at inlet an outlet. (G. Wylie - FPIIB) FIELD_STRUCT_DESC: 24-inch corrugated metal gravity drainage pipe through the levee, 20.5 feet below the crown. Flap gate and headwall on the waterside (WS) end. (Due to a recent change in the levee alignment, this pipe is no longer in RD0784, Unit 6. Nevertheless, this pipe's original references remain in the RD0784 Levee Log and O&M Manual). [Additional Reference(s): DWR Levee Log, 2005. USACE Sacramento O&M Manual 145.1, August 1955, (Station 35+57), As-Built Drawing No. 2-4-106, Sheet 4, (Station 35+57)]. FS Date: 10/30/2018 1:50:00 PM

Pipe on LS toe corroded through.

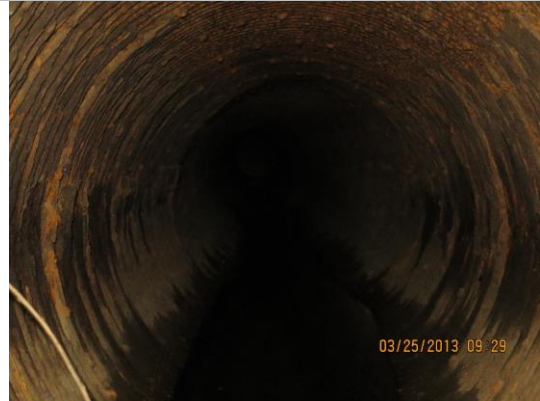
Photo 2 of 3 : UCIP_SP_2019_53420_53848.jpg

Comment Code						
Inspector Comment						
FS_ID:53420 DS_ID:22950 EP_NO: N/A Repair Type: Urgent Crossing Status: Found UCIP Comments: 10/30/2018 Same as last inspection. Pipe has several sections of wall missing throughout the pipe length, and there is significant pipe deformation on the LS. Spoke with Tom Engler (MBK Engineers), District Engineer, and he mentioned that a video inspection has been completed at this site and that a report is in progress. LMA will be seeking funding for pipe repair under DWR's Deferred Maintenance Project (DMP). Crossing remains Urgent due to the deteriorated condition of the pipe. (O. Magana - DWR UCIP)06/30/2016 Holes still present through pipe on corroded landside (LS) end. Pipe still half full of debris as visible thru LS end. Good candidate for removal via DWR's Deferred Maintenance Program. WS vegetation cleared in the immediate vicinity of flapgate. Potential for overgrowth at WS end nevertheless imminent. Note that this pipe does not cause LS nuisance flooding per Tom Engler of MBK. (K. Fazel - UCIP)03/25/2013 Pipe heavily corroded and failing at inlet an outlet. (G. Wylie - FPIIB) FIELD_STRUCT_DESC: 24-inch corrugated metal gravity drainage pipe through the levee, 20.5 feet below the crown. Flap gate and headwall on the waterside (WS) end. (Due to a recent change in the levee alignment, this pipe is no longer in RD0784, Unit 6. Nevertheless, this pipe's original references remain in the RD0784 Levee Log and O&M Manual). [Additional Reference(s): DWR Levee Log, 2005. USACE Sacramento O&M Manual 145.1, August 1955, (Station 35+57), As-Built Drawing No. 2-4-106, Sheet 4, (Station 35+57)]. FS Date: 10/30/2018 1:50:00 PM

Pipe Heavily corroded throughout

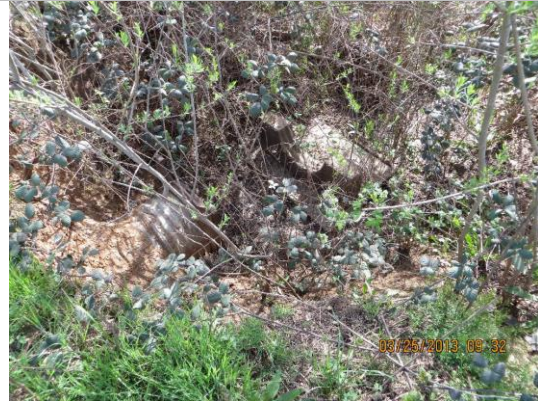
Photo 3 of 3 : UCIP_SP_2019_53420_53847.jpg

Comment Code						
Inspector Comment						
FS_ID:53420 DS_ID:22950 EP_NO: N/A Repair Type: Urgent Crossing Status: Found UCIP Comments: 10/30/2018 Same as last inspection. Pipe has several sections of wall missing throughout the pipe length, and there is significant pipe deformation on the LS. Spoke with Tom Engler (MBK Engineers), District Engineer, and he mentioned that a video inspection has been completed at this site and that a report is in progress. LMA will be seeking funding for pipe repair under DWR's Deferred Maintenance Project (DMP). Crossing remains Urgent due to the deteriorated condition of the pipe. (O. Magana - DWR UCIP)06/30/2016 Holes still present through pipe on corroded landside (LS) end. Pipe still half full of debris as visible thru LS end. Good candidate for removal via DWR's Deferred Maintenance Program. WS vegetation cleared in the immediate vicinity of flapgate. Potential for overgrowth at WS end nevertheless imminent. Note that this pipe does not cause LS nuisance flooding per Tom Engler of MBK. (K. Fazel - UCIP)03/25/2013 Pipe heavily corroded and failing at inlet an outlet. (G. Wylie - FPIIB) FIELD_STRUCT_DESC: 24-inch corrugated metal gravity drainage pipe through the levee, 20.5 feet below the crown. Flap gate and headwall on the waterside (WS) end. (Due to a recent change in the levee alignment, this pipe is no longer in RD0784, Unit 6. Nevertheless, this pipe's original references remain in the RD0784 Levee Log and O&M Manual). [Additional Reference(s): DWR Levee Log, 2005. USACE Sacramento O&M Manual 145.1, August 1955, (Station 35+57), As-Built Drawing No. 2-4-106, Sheet 4, (Station 35+57)]. FS Date: 10/30/2018 1:50:00 PM

Pipe no longer mounted to headwall at WS toe.

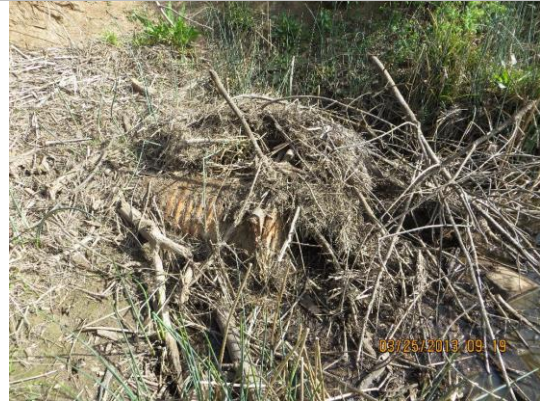
Photo 1 of 3 : UCIP_SP_2019_53421_53854.jpg

UCIP Comments: 10/30/2018 Same as last inspection. Pipe wall has corroded significantly (pipe wall missing) at the outlet. Spoke with Tom Engler (MBK Engineers), District Engineer, and he mentioned that a video inspection has been completed at this site and that a report is in progress. LMA will be seeking funding for pipe repair under DWR's Deferred Maintenance Project (DMP). Crossing remains Urgent due to the deteriorated condition of the pipe. (O. Magana - DWR UCIP)(O. Magana - DWR UCIP)06/30/2016 Corrosion still present on WS end. Inlet box was replaced 5 years ago and appears to be functioning properly due to the presence of a screen that prevents debris blockage. Flap gate functions properly only sometimes. WS heavily vegetated. (K. Fazel - UCIP) 03/25/2013 Corrosion holes on WS toe and flap gate is blocked by debris. Flap gate broken. Inlet partially blocked at concrete inlet. (G. Wylie - FPIIB)

Pipe and flapgate at WS toe blocked by debris.

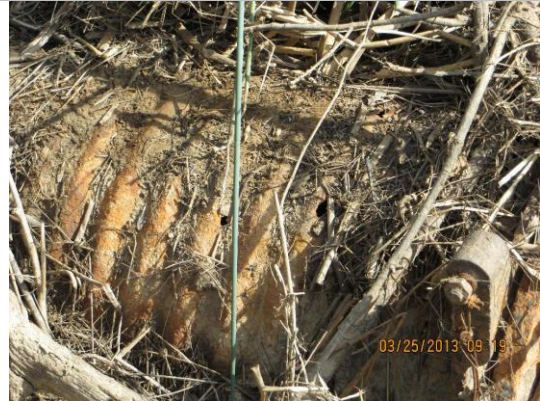
Photo 2 of 3 : UCIP_SP_2019_53421_53853.jpg

UCIP Comments: 10/30/2018 Same as last inspection. Pipe wall has corroded significantly (pipe wall missing) at the outlet. Spoke with Tom Engler (MBK Engineers), District Engineer, and he mentioned that a video inspection has been completed at this site and that a report is in progress. LMA will be seeking funding for pipe repair under DWR's Deferred Maintenance Project (DMP). Crossing remains Urgent due to the deteriorated condition of the pipe. (O. Magana - DWR UCIP)(O. Magana - DWR UCIP)06/30/2016 Corrosion still present on WS end. Inlet box was replaced 5 years ago and appears to be functioning properly due to the presence of a screen that prevents debris blockage. Flap gate functions properly only sometimes. WS heavily vegetated. (K. Fazel - UCIP) 03/25/2013 Corrosion holes on WS toe and flap gate is blocked by debris. Flap gate broken. Inlet partially blocked at concrete inlet. (G. Wylie - FPIIB)

Holes in pipe at broken flapgate on WS toe.

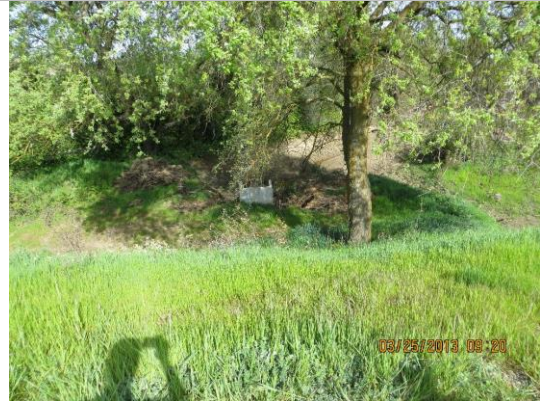
Photo 3 of 3 : UCIP_SP_2019_53421_53852.jpg

Comment Code						
Inspector Comment						
FS_ID:53421 DS_ID:22951 EP_NO: N/A Repair Type: Urgent Crossing Status: Found UCIP Comments: 10/30/2018 Same as last inspection. Pipe wall has corroded significantly (pipe wall missing) at the outlet. Spoke with Tom Engler (MBK Engineers), District Engineer, and he mentioned that a video inspection has been completed at this site and that a report is in progress. LMA will be seeking funding for pipe repair under DWR's Deferred Maintenance Project (DMP). Crossing remains Urgent due to the deteriorated condition of the pipe. (O. Magana - DWR UCIP)(O. Magana - DWR UCIP)06/30/2016 Corrosion still present on WS end. Inlet box was replaced 5 years ago and appears to be functioning properly due to the presence of a screen that prevents debris blockage. Flap gate functions properly only sometimes. WS heavily vegetated. (K. Fazel - UCIP) 03/25/2013 Corrosion holes on WS toe and flap gate is blocked by debris. Flap gate broken. Inlet partially blocked at concrete inlet. (G. Wylie - FPIIB) FIELD_STRUCT_DESC: 24-inch corrugated metal gravity drainage pipe through the levee, 20 feet below the crown. Flap gate and headwall on the waterside (WS) end. 56-inch by 34-inch concrete inlet box on the landside (LS) toe. (Due to a recent change in the levee alignment, this pipe is no longer in RD0784, Unit 6. Nevertheless, this pipe's original references remain in the RD0784 Levee Log and O&M Manual). [Additional Reference(s): DWR Levee Log, 2005. USACE Sacramento O&M Manual 145.1, August 1955, (Station 43+17), As-Built Drawing No. 2-4-106, Sheet 4, (Station 43+17)]. FS Date: 10/30/2018 1:51:00 PM

Improved concrete inlet on LS toe.

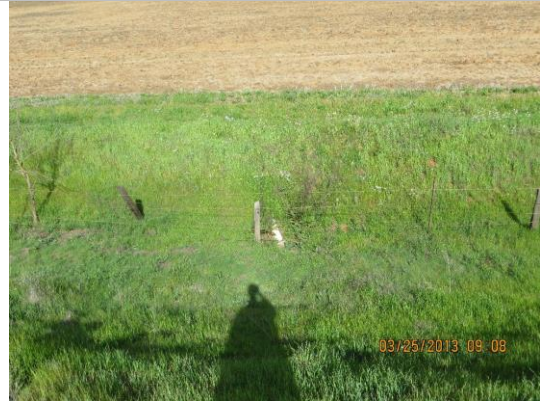
Photo 1 of 3 : UCIP_SP_2019_53422_53857.jpg

UCIP Comments: 10/30/2018 Same as last inspection. Pipe has deteriorated significantly and is no longer used as noted in the 2016 inspection. Spoke with Tom Engler with MBK, District Engineer, and he mentioned that a video inspection has been completed and that a report is in progress. LMA will be seeking funding to address pipe under DWR's Deferred Maintenance Project (DMP). Crossing remains Urgent due to the deteriorated condition of the pipe. (O. Magana - DWR UCIP)06/30/2016 Same as last inspection. Good candidate for removal via DWR's Deferred Maintenance Program. Pipe used to drain pastureland which have since been converted to rice fields that drain on opposite side of fields, rendering the drainage function of this pipe obsolete. This pipe is not needed and causes nuisance flooding at high water on landside (LS) per Tom Engler of MBK. As such, operation of flapgate is still blocked via a post at WS end. Pipe is sleeved but sleeve has grossly deteriorated. LS end of pipe appears bent. (K. Fazel - UCIP)03/25/2013 Pipe heavily corroded and damaged. 8-inch PVC pipe runs through pipe/possibly for irrigation. CMP heavily rusted on WS toe and debris blocking flap gate on WS toe. (G. Wylie - FPIIB) FIELD_STRUCT_DESC: *ABANDONED* 20-inch corrugated metal gravity drainage pipe through the levee, 16.5 feet below the crown. 8-inch polyvinyl chloride (PVC) pipe sleeved through the 20-inch corrugated metal pipe with the annular space left void. Flap gate on the waterside (WS) end. (Due to a recent change in the levee alignment, this pipe is no longer in RD0784, Unit 6. Nevertheless, this pipe's original references remain in the RD0784 Levee Log and O&M Manual). [Additional Reference(s): DWR Levee Log, 2005, 24-inch corrugated metal pipe (CMP) referenced. USACE Sacramento O&M Manual 145.1, August 1955, (Station 69+17), 18-inch CMP referenced, As-Built Drawing No. 2-4-106, Sheet 4, (Station 69+17)].

Pipe on LS toe with 8-inch PVC pipe sticking out.

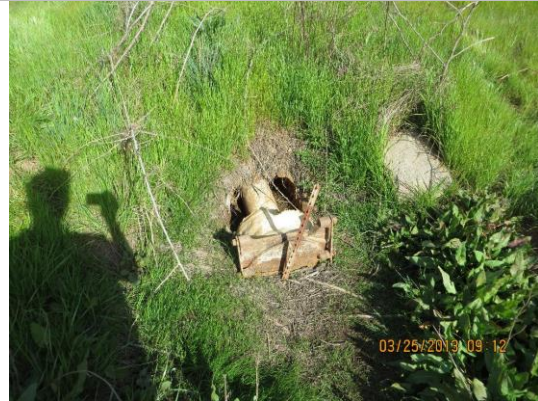
Photo 2 of 3 : UCIP_SP_2019_53422_53856.jpg

Comment Code						
Inspector Comment						
FS_ID:53422 DS_ID:22952 EP_NO: N/A Repair Type: Urgent Crossing Status: Found UCIP Comments: 10/30/2018 Same as last inspection. Pipe has deteriorated significantly and is no longer used as noted in the 2016 inspection. Spoke with Tom Engler with MBK, District Engineer, and he mentioned that a video inspection has been completed and that a report is in progress. LMA will be seeking funding to address pipe under DWR's Deferred Maintenance Project (DMP). Crossing remains Urgent due to the deteriorated condition of the pipe. (O. Magana - DWR UCIP)06/30/2016 Same as last inspection. Good candidate for removal via DWR's Deferred Maintenance Program. Pipe used to drain pastureland which have since been converted to rice fields that drain on opposite side of fields, rendering the drainage function of this pipe obsolete. This pipe is not needed and causes nuisance flooding at high water on landside (LS) per Tom Engler of MBK. As such, operation of flapgate is still blocked via a post at WS end. Pipe is sleeved but sleeve has grossly detereorated. LS end of pipe appears bent. (K. Fazel - UCIP)03/25/2013 Pipe heavily corroded and damaged. 8-inch PVC pipe runs through pipe/possibly for irrigation. CMP heavily rusted on WS toe and debris blocking flap gate on WS toe. (G. Wylie - FPIIB) FIELD_STRUCT_DESC: *ABANDONED* 20-inch corrugated metal gravity drainage pipe through the levee, 16.5 feet below the crown. 8-inch polyvinyl chloride (PVC) pipe sleeved through the 20-inch corrugated metal pipe with the annular space left void. Flap gate on the waterside (WS) end. (Due to a recent change in the levee alignment, this pipe is no longer in RD0784, Unit 6. Nevertheless, this pipe's original references remain in the RD0784 Levee Log and O&M Manual). [Additional Reference(s): DWR Levee Log, 2005, 24-inch corrugated metal pipe (CMP) referenced. USACE Sacramento O&M Manual 145.1, August 1955, (Station 69+17), 18-inch CMP referenced, As-Built Drawing No. 2-4-106, Sheet 4, (Station 69+17)]. FS Date: 10/30/2018

Pipe cut behind flap gate on WS toe with 8-inch PVC.

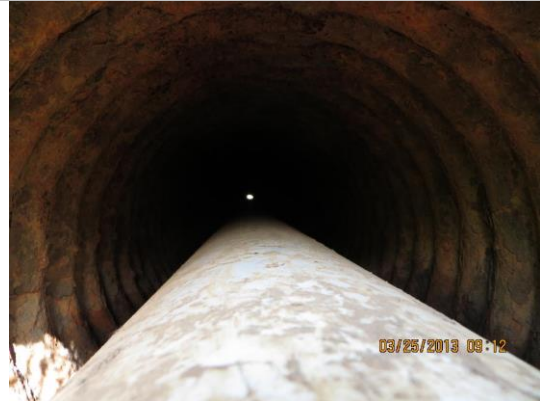
Photo 3 of 3 : UCIP_SP_2019_53422_53855.jpg

FS_ID:53422
 DS_ID:22952
 EP_NO: N/A
 Repair Type: Urgent
 Crossing Status: Found
 UCIP Comments: 10/30/2018 Same as last inspection. Pipe has deteriorated significantly and is no longer used as noted in the 2016 inspection. Spoke with Tom Engler with MBK, District Engineer, and he mentioned that a video inspection has been completed and that a report is in progress. LMA will be seeking funding to address pipe under DWR's Deferred Maintenance Project (DMP). Crossing remains Urgent due to the deteriorated condition of the pipe. (O. Magana - DWR UCIP)06/30/2016 Same as last inspection. Good candidate for removal via DWR's Deferred Maintenance Program. Pipe used to drain pastureland which have since been converted to rice fields that drain on opposite side of fields, rendering the drainage function of this pipe obsolete. This pipe is not needed and causes nuisance flooding at high water on landside (LS) per Tom Engler of MBK. As such, operation of flapgate is still blocked via a post at WS end. Pipe is sleeved but sleeve has grossly deteriorated. LS end of pipe appears bent. (K. Fazel - UCIP)03/25/2013 Pipe heavily corroded and damaged. 8-inch PVC pipe runs through pipe/possibly for irrigation. CMP heavily rusted on WS toe and debris blocking flap gate on WS toe. (G. Wylie - FPIIB) FIELD_STRUCT_DESC: *ABANDONED* 20-inch corrugated metal gravity drainage pipe through the levee, 16.5 feet below the crown. 8-inch polyvinyl chloride (PVC) pipe sleeved through the 20-inch corrugated metal pipe with the annular space left void. Flap gate on the waterside (WS) end. (Due to a recent change in the levee alignment, this pipe is no longer in RD0784, Unit 6. Nevertheless, this pipe's original references remain in the RD0784 Levee Log and O&M Manual). [Additional Reference(s): DWR Levee Log, 2005, 24-inch corrugated metal pipe (CMP) referenced. USACE Sacramento O&M Manual 145.1, August 1955, (Station 69+17), 18-inch CMP referenced, As-Built Drawing No. 2-4-106, Sheet 4, (Station 69+17)].

Pipe heavily corroded throughout.

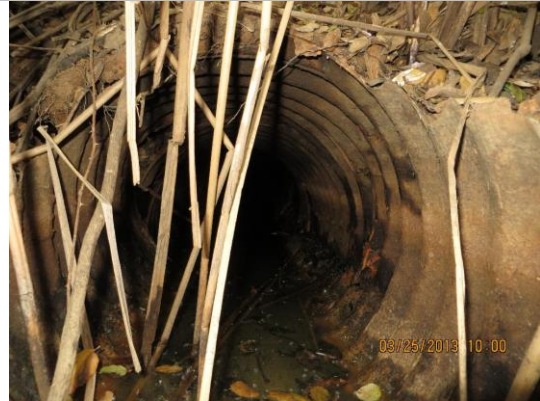
Photo 1 of 3 : UCIP_SP_2019_53423_53859.jpg

FS_ID:53423
DS_ID:22953
EP_NO: N/A
Repair Type: Urgent
Crossing Status: Found
UCIP Comments: 10/30/2018 Same as last inspection. Pipe has large sections of its wall missing due to heavy corrosion on both the WS and the LS. Sink hole visible on LS along pipe alignment. Spoke with Tom Engler with MBK, District Engineer, and he mentioned that a video inspection has been completed and that a report is in progress. LMA will be seeking funding for pipe repair under DWR's Deferred Maintenance Project (DMP). Crossing remains Urgent due to the deteriorated condition of the pipe. (O. Magana - DWR UCIP)06/30/2016 Sink hole still exists over pipe on LS. LS and WS heavily vegetated and barely accessible. WS end is sleeved with a heavily rusted CMP. Flapgate is clear and functional. (K. Fazel - UCIP)12/17/2015 WS accessible, but LS no longer accessible due to heavy vegetation. (T. Hatch - UCIP)03/25/2013 Pipe visible on LS at toe of roadway embankment, but not visible on WS. Possible sinkhole over pipe at LS toe. Pipe heavily rusted. (G. Wylie - FPIIB)

Pipe at inlet on LS toe.

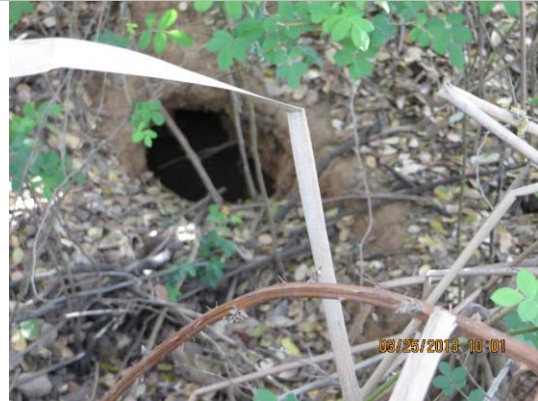
Photo 2 of 3 : UCIP_SP_2019_53423_53858.jpg

Comment Code						
Inspector Comment						
FS_ID:53423 DS_ID:22953 EP_NO: N/A Repair Type: Urgent Crossing Status: Found UCIP Comments: 10/30/2018 Same as last inspection. Pipe has large sections of its wall missing due to heavy corrosion on both the WS and the LS. Sink hole visible on LS along pipe alignment. Spoke with Tom Engler with MBK, District Engineer, and he mentioned that a video inspection has been completed and that a report is in progress. LMA will be seeking funding for pipe repair under DWR's Deferred Maintenance Project (DMP). Crossing remains Urgent due to the deteriorated condition of the pipe. (O. Magana - DWR UCIP)06/30/2016 Sink hole still exists over pipe on LS. LS and WS heavily vegetated and barely accessible. WS end is sleeved with a heavily rusted CMP. Flapgate is clear and functional. (K. Fazel - UCIP)12/17/2015 WS accessible, but LS no longer accessible due to heavy vegetation. (T. Hatch - UCIP)03/25/2013 Pipe visible on LS at toe of roadway embankment, but not visible on WS. Possible sinkhole over pipe at LS toe. Pipe heavily rusted. (G. Wylie - FPIIB) FIELD_STRUCT_DESC: 18-inch corrugated metal gravity drainage pipe angled through the levee, approximately 15 feet below the crown. Steel pipe sleeved through the 18-inch corrugated metal pipe (CMP) with annular space grouted, grout only on the waterside (WS). Flap gate on the WS end. Pipe alignment is from the west of the intersection of Forty Mile Road and 45 degrees to the WS. Outlet is on the eastern side of Forty Mile Road, looking upstream. (Due to a recent change in the levee alignment, this pipe is no longer in RD0784, Unit 6. Nevertheless, this pipe's original references remain in the RD0784 Levee Log and O&M Manual). [Additional Reference(s): DWR Levee Log, 2005, USACE Sacramento O&M Manual 145.1, August 1955, (Station 74+72), As-Built Drawing No. 2-4-106, Sheet 4, (Station 74+72)]. FS Date: 10/30/2018

Sinkhole or animal burrow over pipe on LS toe.

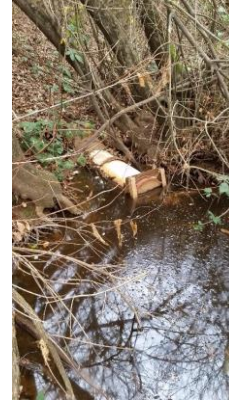
Photo 3 of 3 : UCIP_SP_2019_53423_74804.jpg

Comment Code						
Inspector Comment						
FS_ID:53423 DS_ID:22953 EP_NO: N/A Repair Type: Urgent Crossing Status: Found UCIP Comments: 10/30/2018 Same as last inspection. Pipe has large sections of its wall missing due to heavy corrosion on both the WS and the LS. Sink hole visible on LS along pipe alignment. Spoke with Tom Engler with MBK, District Engineer, and he mentioned that a video inspection has been completed and that a report is in progress. LMA will be seeking funding for pipe repair under DWR's Deferred Maintenance Project (DMP). Crossing remains Urgent due to the deteriorated condition of the pipe. (O. Magana - DWR UCIP)06/30/2016 Sink hole still exists over pipe on LS. LS and WS heavily vegetated and barely accessible. WS end is sleeved with a heavily rusted CMP. Flapgate is clear and functional. (K. Fazel - UCIP)12/17/2015 WS accessible, but LS no longer accessible due to heavy vegetation. (T. Hatch - UCIP)03/25/2013 Pipe visible on LS at toe of roadway embankment, but not visible on WS. Possible sinkhole over pipe at LS toe. Pipe heavily rusted. (G. Wylie - FPIIB) FIELD_STRUCT_DESC: 18-inch corrugated metal gravity drainage pipe angled through the levee, approximately 15 feet below the crown. Steel pipe sleeved through the 18-inch corrugated metal pipe (CMP) with annular space grouted, grout only on the waterside (WS). Flap gate on the WS end. Pipe alignment is from the west of the intersection of Forty Mile Road and 45 degrees to the WS. Outlet is on the eastern side of Forty Mile Road, looking upstream. (Due to a recent change in the levee alignment, this pipe is no longer in RD0784, Unit 6. Nevertheless, this pipe's original references remain in the RD0784 Levee Log and O&M Manual). [Additional Reference(s): DWR Levee Log, 2005, USACE Sacramento O&M Manual 145.1, August 1955, (Station 74+72), As-Built Drawing No. 2-4-106, Sheet 4, (Station 74+72)]. FS Date: 10/30/2018

WS drainage outlet with flap gate. Steel pipe is sleeved within heavily rusted CM pipe near daylight to embankment
